Research Report
UKTRP-84-1

RUTTING: A CASE STUDY
(US 23; 1.5 Miles North of Louisa)

Kentucky Transportation Research Program
College of Engineering
University of Kentucky

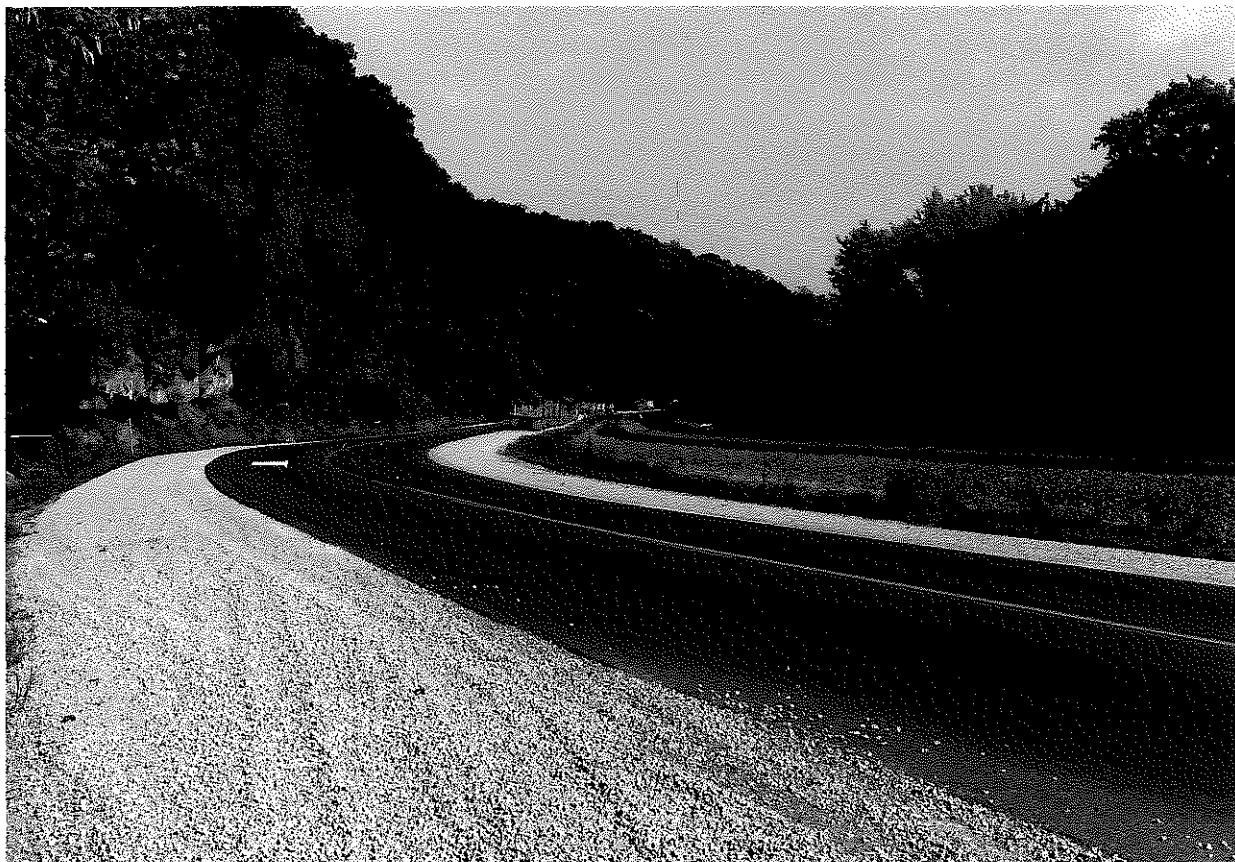
Figure 1. US 23, South of Ashland Refinery; Coal Trucks (5-axle semi's) Awaiting Entry into Unloading Yard. About 3:00 pm, 37 Trucks, Extending Back beyond the Photo, Were Waiting.

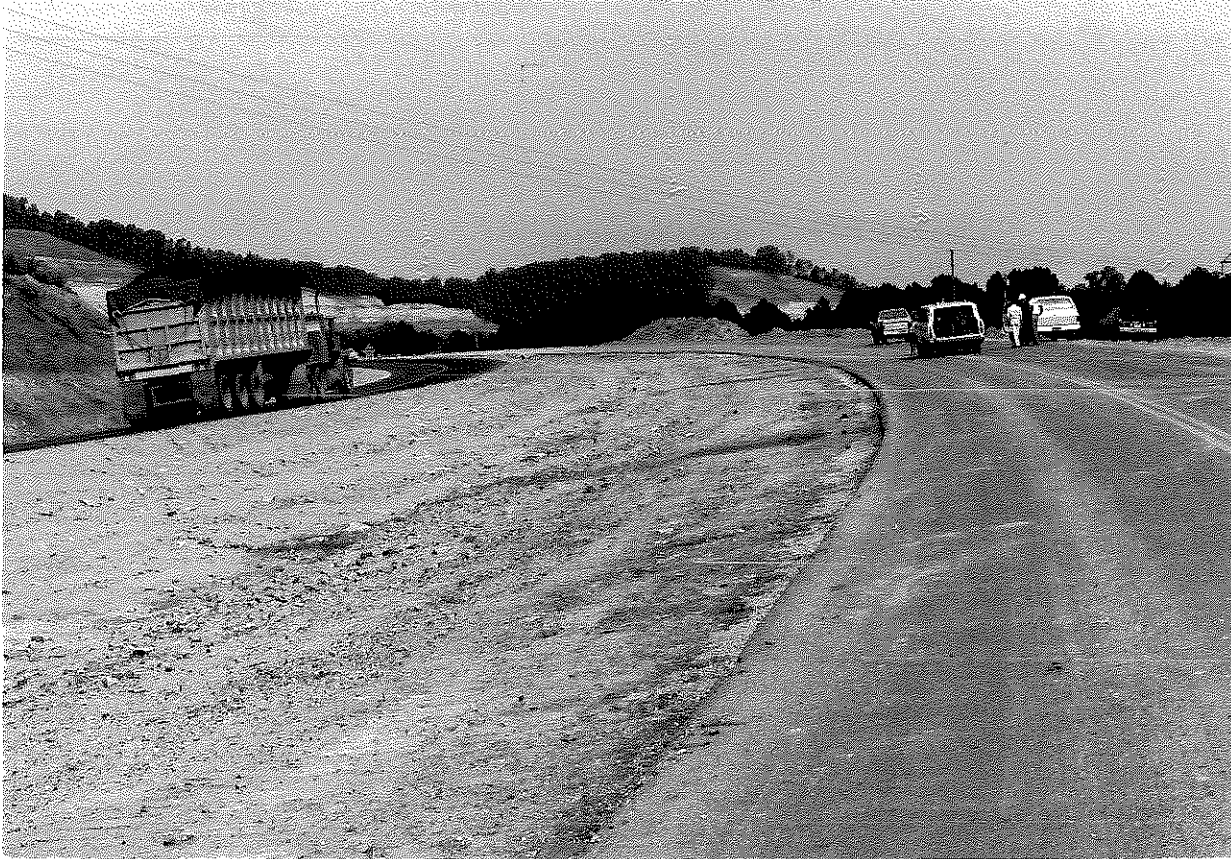
Figure 2. Station 59+00; Site of Greatest Rutting; Chosen for Trenching; Road Rater Tests in Progress. Note Coal Truck at Left and Absence of Shoulder; Dark Spots are Inside Sand Drains.

Station 59+00 was chosen because the rutting there exceeded 1.5 inches (Figure 3). Station 56+40 was chosen because rutting was minimal there. The exposures were made September 15, 1983.

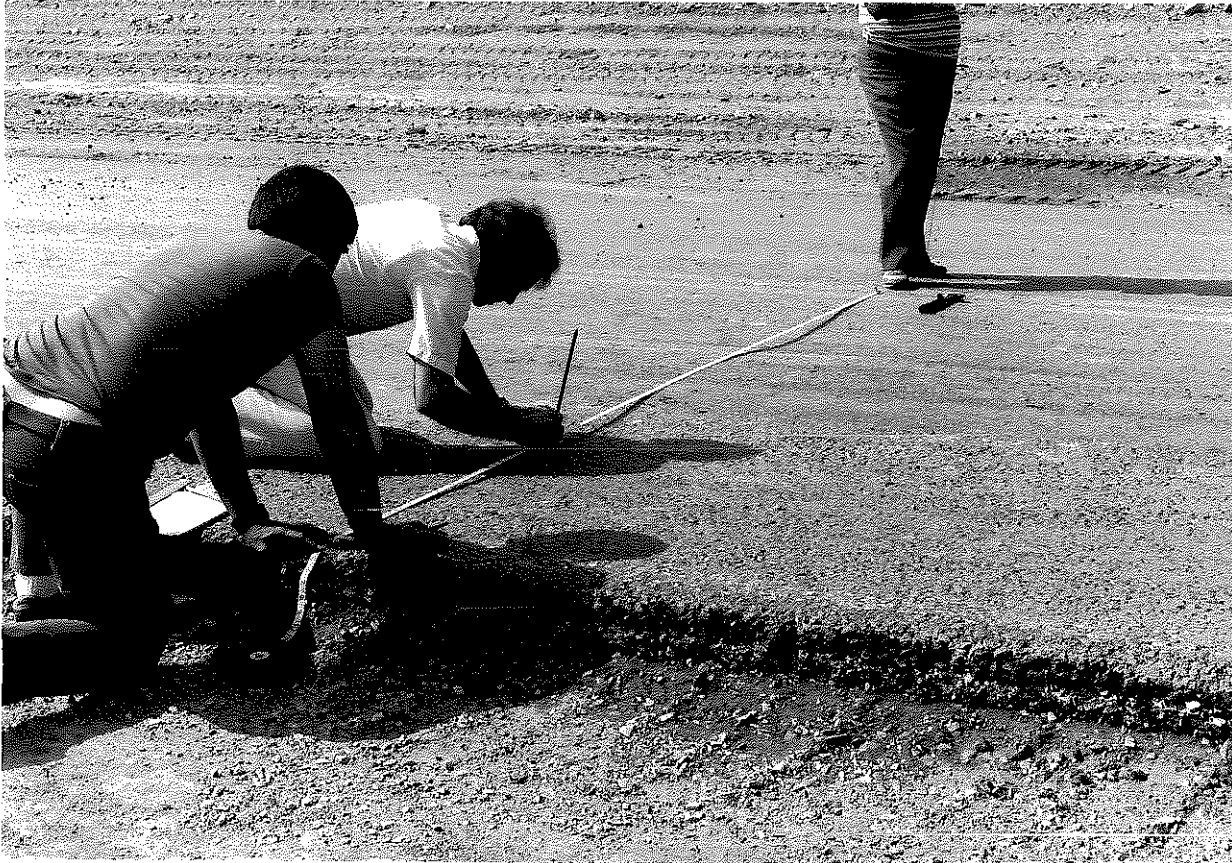
Figure 3. Profiling Surface in Outer Lane; Station 59+00. Note
Absence of Outside Shoulder Paving.

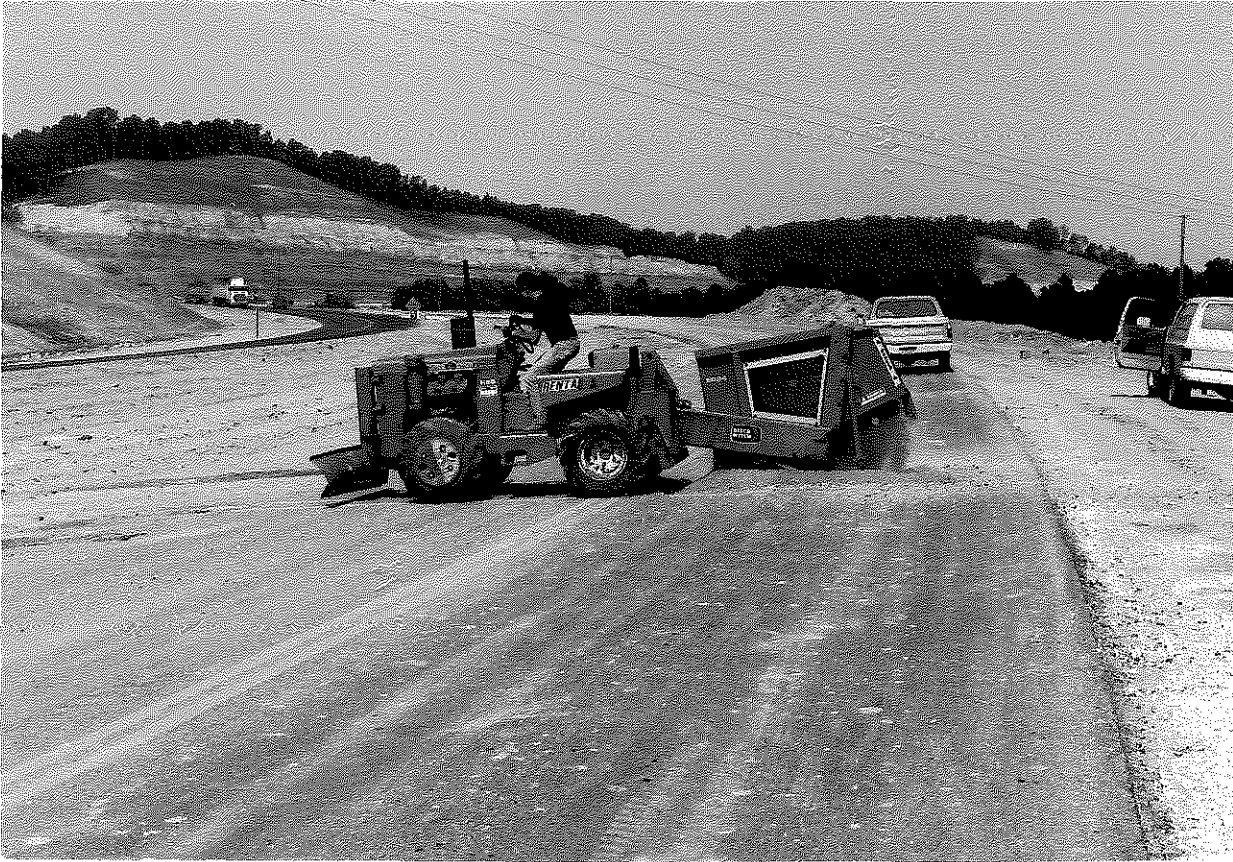
Figure 4. Ditch Witch Earth Saw (ES 24); Cut Approximately Two Feet deep; 10 to 15 Minutes per Cut.

Two cuts were made about two feet apart and about two feet deep. The material between the cuts was removed with a backhoe. The cuts were made with a Ditch Witch Earth Saw (Figure 4). Each cut was about 4 inches wide. Cutting progressed rapidly and without difficulty.

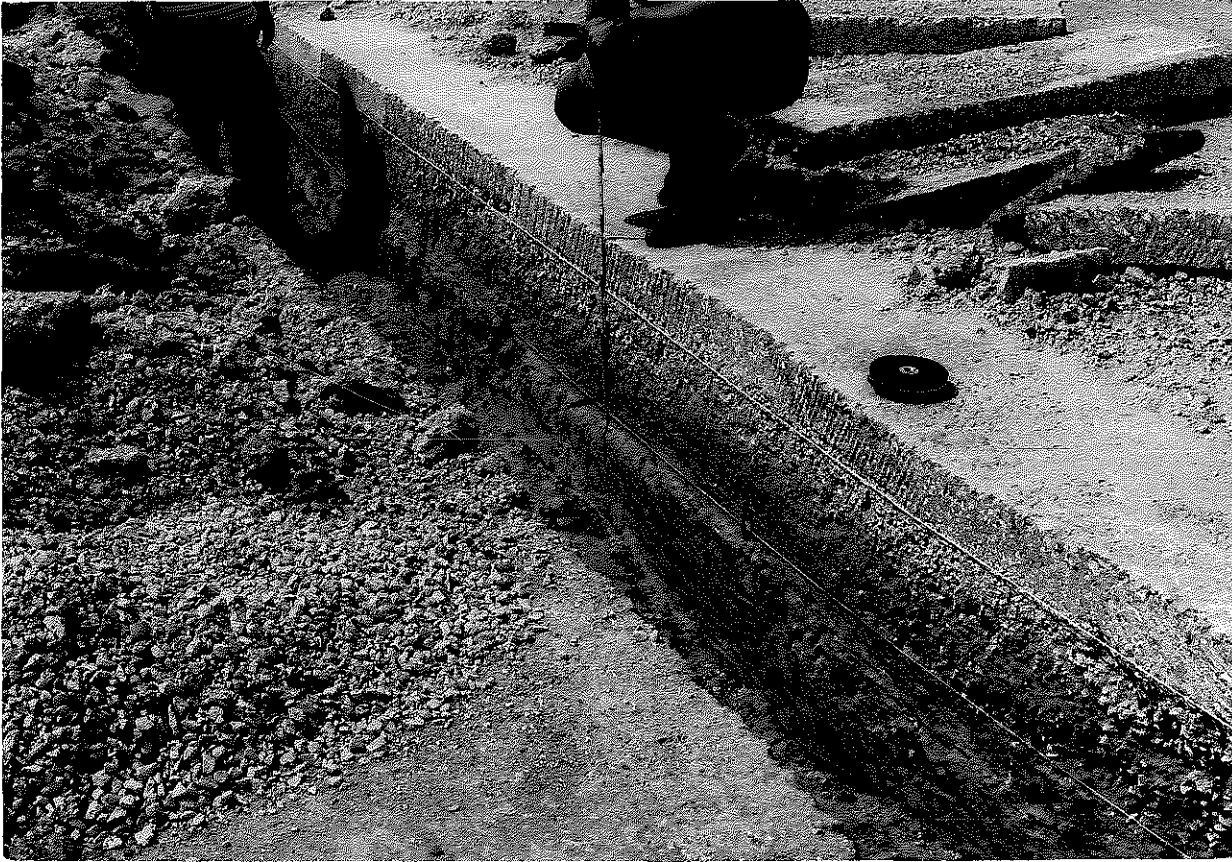
Figure 5. Station 59+00; Rutting and Thinning in Wheelpaths; Heaving (Upthrusting) between Wheelpaths; Plastic Soil in Subgrade in Foreground; Sandy Material in Background (See Figure 8).

Analysis of the US-23 rutting was simply a cause-and-effect approach. Plastic soil was found under the dense-graded aggregate where rutting was greatest (Figures 5, 6, 7, and 8). The material there should have been rock subgrade. At Station 56+40, chunky shale (Figure 9) was found under the dense-graded aggregate. The shale was friable, crumbly, and dry. There the rutting was much less, but the subgrade presumably would not qualify for CBR 11, which was the design value.

Plastic material (soil) was found at Station 59+00 where rock subgrade should have been.

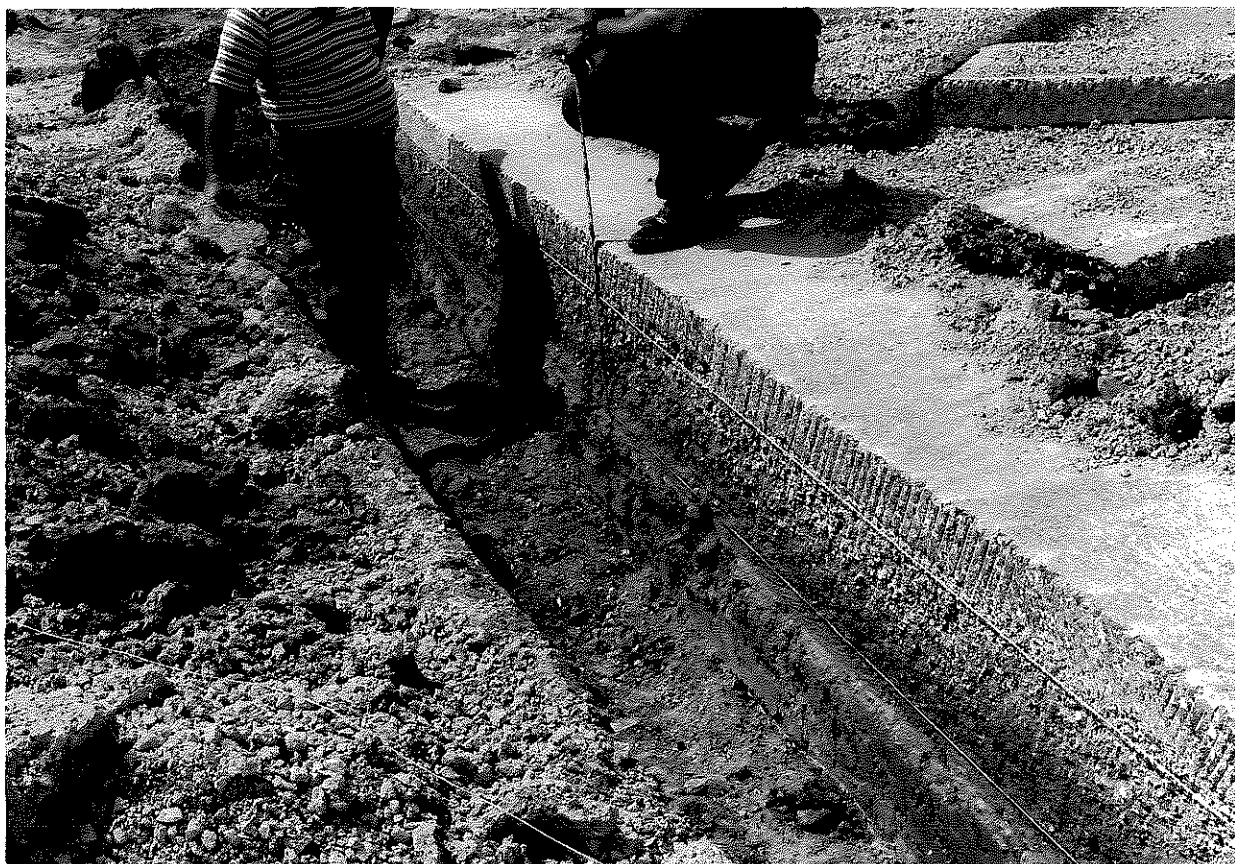
Figure 6. Station 59+00; Inner Lane Unrutted; Sandy Roadbed.

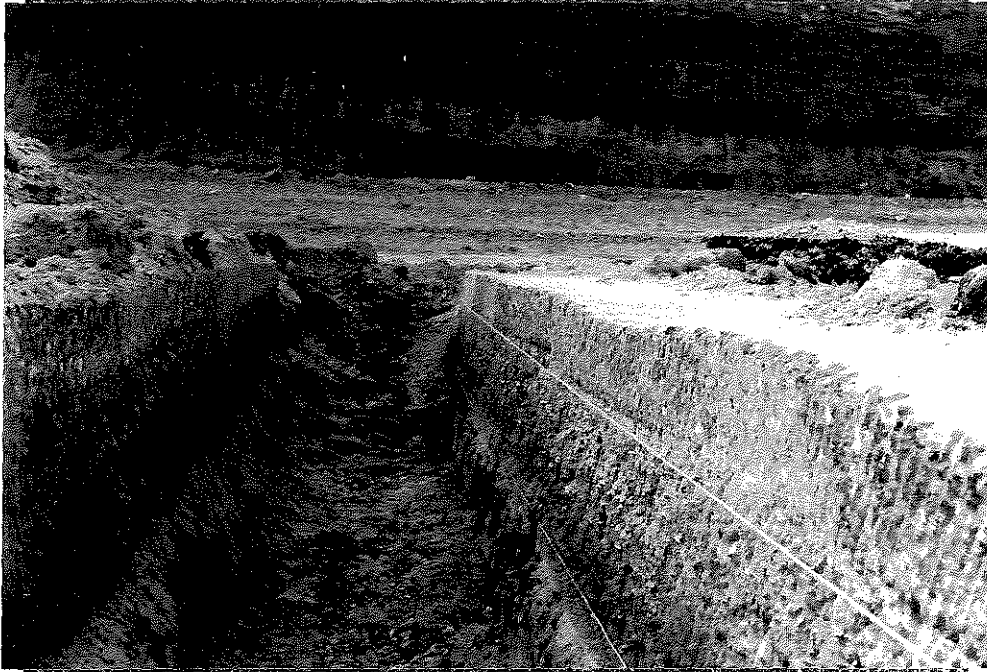
Figure 7. Station 59+00, Brownish Material under Dense-graded Aggregate Base in Inside Lane. Sample for Laboratory Testing Taken from Foreground Contained Appreciable Sand, Sandstone Fragments, and Shale.

Bag samples of the subgrade were collected at both stations. At Station 59+00, the subgrade appeared to be a brown-to-gray sandy clay containing shale fragments (particularly under the inside lane). Under the outside lane, the subgrade gradually became a bluish-gray clay shale. The in-place moisture content was 7.3 percent. A slake-durability index test (18, 19) was performed on that material according to KM 64-513-79. The SDI was 32.5, which qualifies as soil-like material. By correlation, the CBR would be 2.1 (20). The material also was tested to determine the CBR value according to KM 64-501-80, and the final soaked CBR value was 4.0.

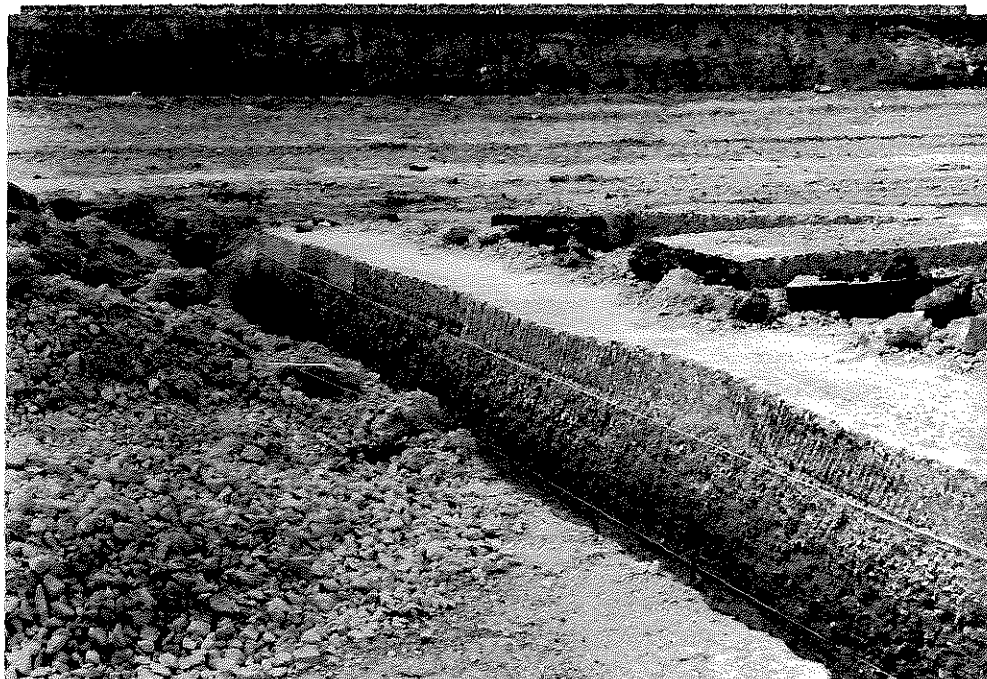
Figure 8. Transition from Brownish Soil (leftward) to Blue-Gray Shale (rightward). Sample was More Representative of Sandstone-Derived Material with Some Shale Than of Purer Shaly Material (rightward) under the Outer Lane.

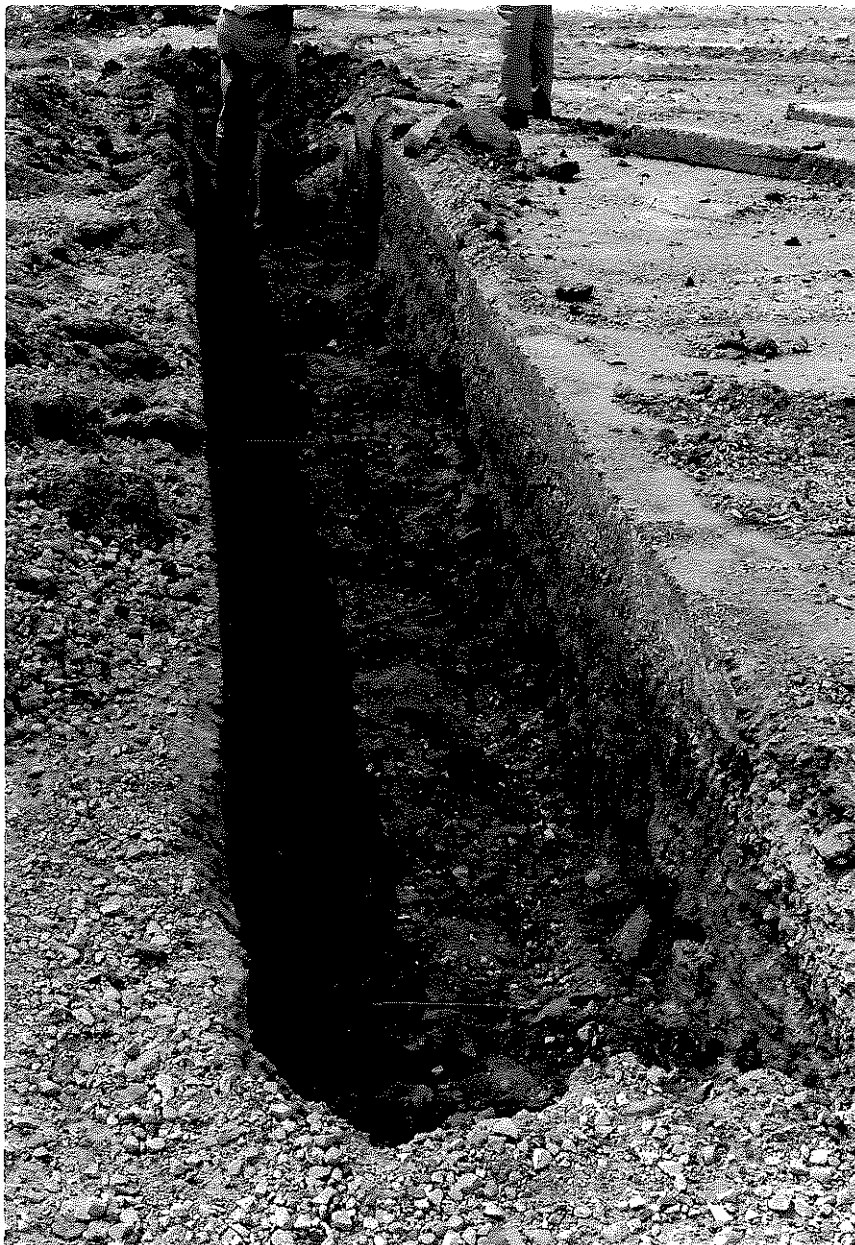
Figure 9. Station 56+40; Lesser Rutting; Chunky, Friable Dark Shale in Roadbed; Relatively Dry; No Free Water.

At Station 56+40, the subgrade was a gray clayey shale with chunky particles as large as 6 inches. The in situ moisture content was 6.5 percent. The slake durability index of the material was 81.8. This would classify as an intermediate material between rock and soil. A CBR test was not performed on the subgrade of this station. By correlation (20) the CBR would be 4.8.

Chunky, friable shale was found at Station 56+40, where rock subgrade should have been. According to past practices, high-quality rock roadbed material would have been credited with a CBR of 11. Shaly or lesser quality rock would have been credited with a CBR of 9. The Slake Durability Test would have disqualified the shale for service as rock subgrade material.

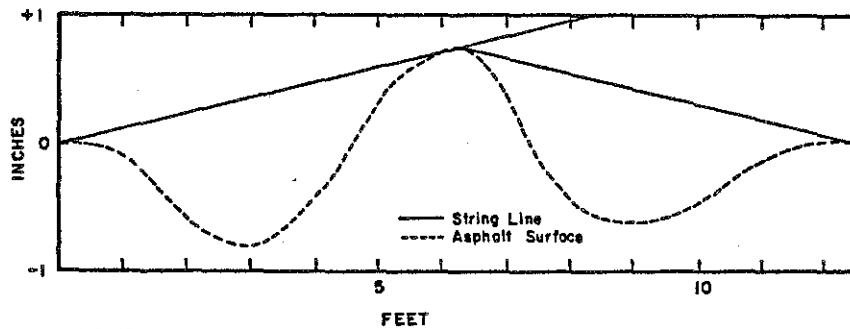
Figure 10. Rutting as Deviations from String Line; Station 59+00; Northbound Lane Only.

Deviations from string lines are shown in Figures 10 through 13. The maximum depth of rutting was 0.63 inches in the outer wheel path at Station 59+00. There was an apparent heave of 0.75 inches between the two wheelpaths of the outer lane at that point. Thus, the total deformation there was 1.38 inches. Blue-gray shale (plastic) was found at that point.

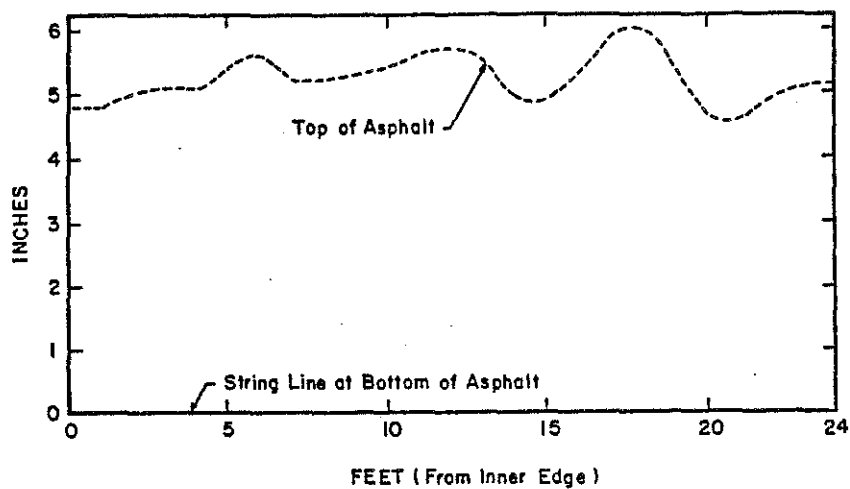
Figure 11. Surface Profile Shown Graphically as Deviations from a String Line at the Bottom of the Asphaltic Concrete; Station 59+00; Both Lanes.

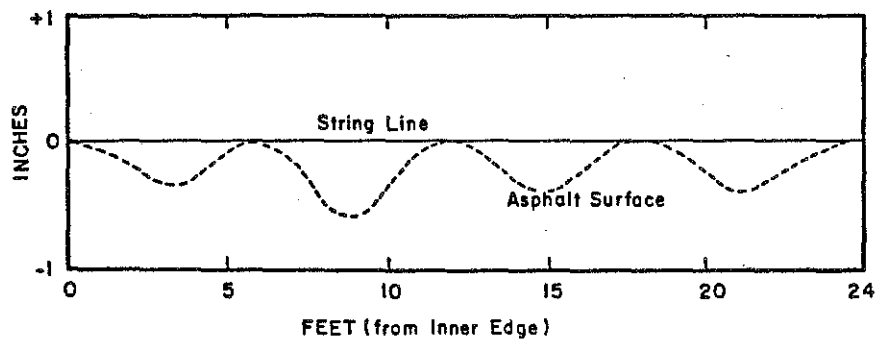
Figure 12. Surface Profile Shown Graphically as Deviations from String Line; Station 56+40; Both Lanes.

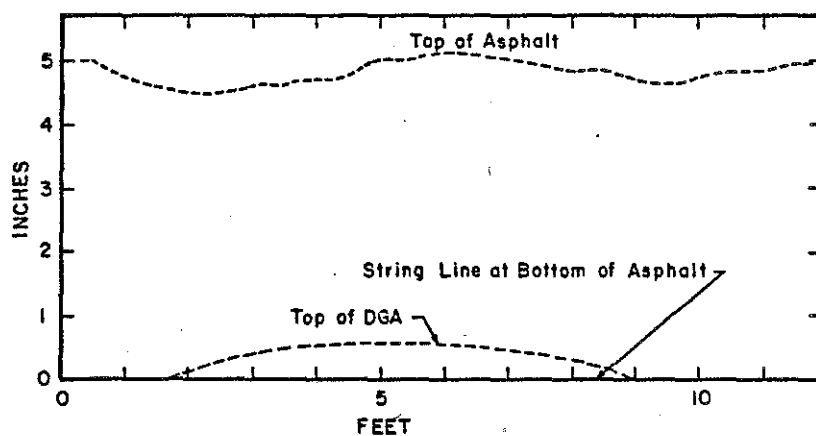
Figure 13. Surface Profile Shown as Deviations from a String Line at the Bottom of the Asphaltic Concrete; Station 56+40; Note Uneven Boundary.

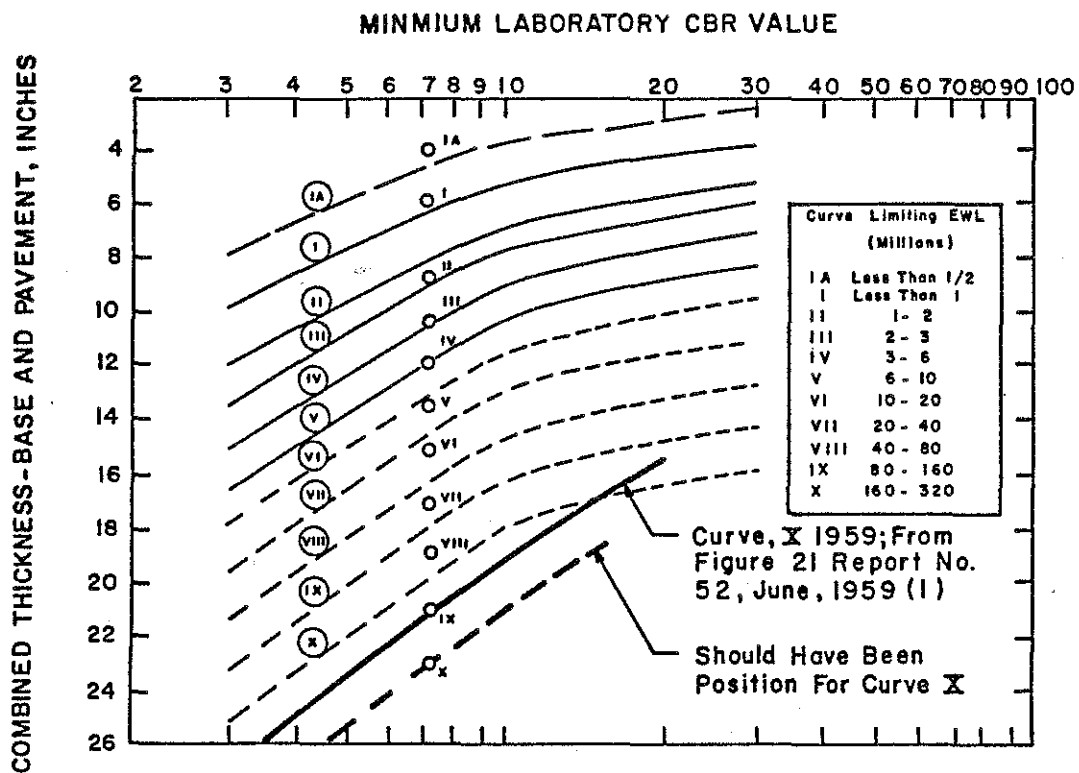
Figure 14. 1947 Design Chart Showing 1959 Revised Thicknesses for Each Median Point of the Traffic Volume Groups, Plotted at an Average CBR of 7.1 (1). Notes are Current.

Thus, use of the 1959 curves resulted in an underdesign for the projected fatigue level ($EWL = 2.39 \times 10^6$) when compared with designs obtained using the 1981 480-ksi design curves. This was further compounded by test data (laboratory and field) that indicated actual field conditions were very much inferior to anticipated design conditions (CBR 5 versus CBR 11). Overlay design calculations were determined using the 1981 flexible design curves (480 ksi) for three projected fatigue levels: 7.47×10^6 EAL's, 9.2×10^6 EAL's, and 2.697×10^7 EAL's. Overlay design calculations also incorporated the condition of the existing pavement structure using deflection data as well as laboratory CBR data. Recommended overlay thicknesses are presented in Table 4.

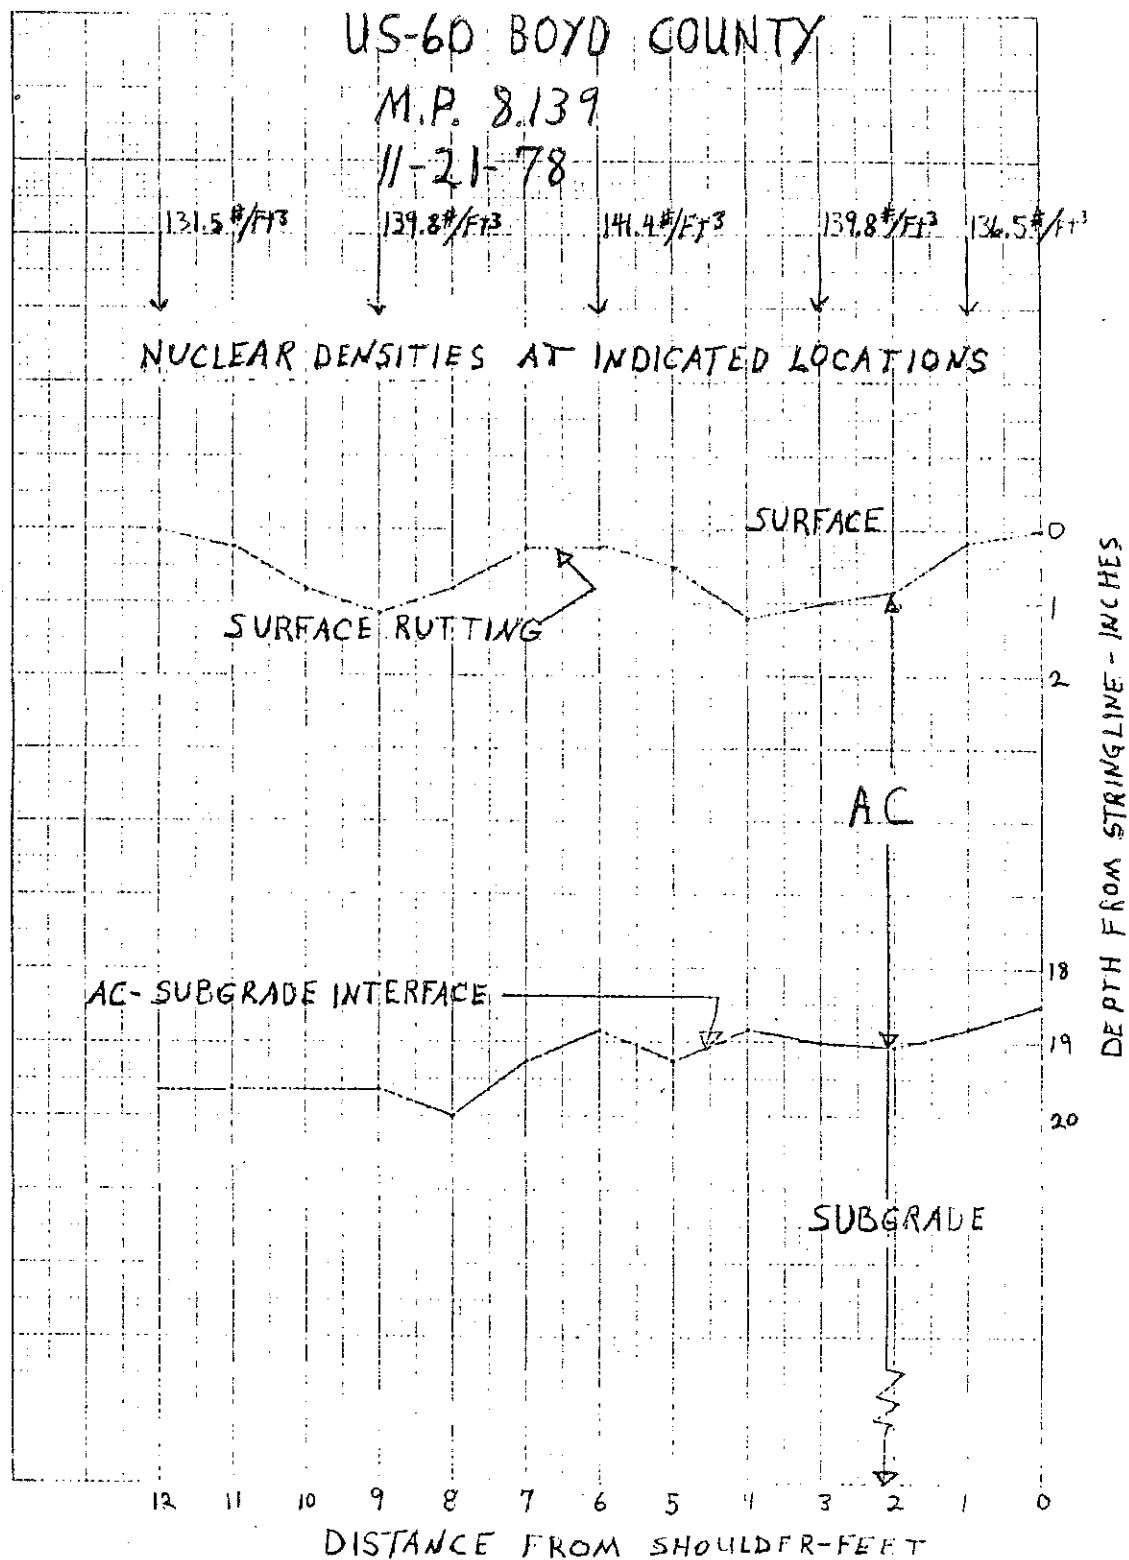
11/21/78 B-40 G. US60 HP B. 139 EASTWARD LAKE 18" FULL DEPTH

Photograph 931-2, of the US 60 cut, exposes the 18-inch, (457 mm) asphalt concrete depth and the surface rutting there. No free-draining water was found in or around the full-depth section.
